December 2017

Subject: Pacemakers – Technical programming information on Minute Ventilation Sensor.

Ref.: 92186345-FA

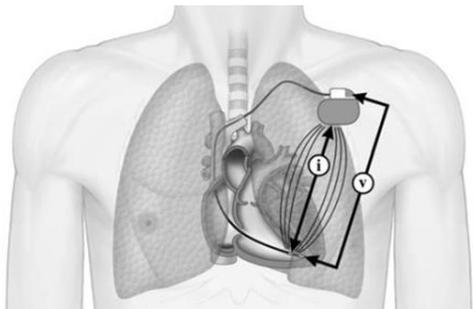
Boston Scientific pacemakers use transthoracic impedance to measure MV which is a product of respiration rate and tidal volume. During inhalation, the increased volume of air in the chest cavity produces an increase in transthoracic impedance. Likewise, during exhalation, the decreased volume of air produces a decrease in transthoracic impedance. Transthoracic impedance measurements are obtained through delivering a subthreshold current waveform approximately every 50 ms between the lead ring electrode and the pacemaker case, and measuring the resultant voltage between the lead tip and the pacemaker case (Figure 1). Boston Scientific pacemakers use the MV sensor for RightRate™ (rate adaptive pacing), Respiratory Rate Trend, and AP Scan™⁶.

Figure 1. Measurement of the MV Signal from the RV lead

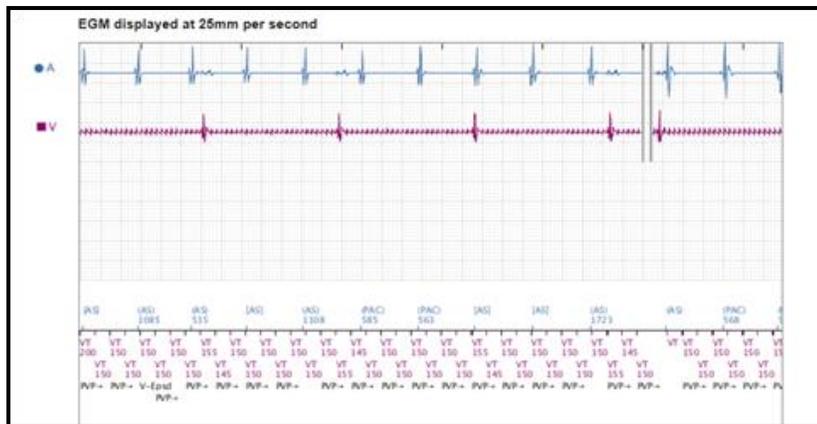
Engineering analysis and testing, as well as evaluation of post-market surveillance data, demonstrates an elevated potential for oversensing of the MV sensor signal in certain pacemaker systems connected to Medtronic or Abbott pacing leads. Although all leads evaluated in simulated testing environments comply with appropriate connector standards³, we have discovered subtle differences amongst lead manufacturers in the surface finish of the lead terminal ring and amount of axial and radial terminal ring motion within the pacemaker header. These factors may result in intermittent increases in impedance leading to oversensing of the MV sensor signal or changes in daily impedance test measurements.

Boston Scientific pacemakers perform an MV lead check approximately every hour to assess lead and lead connection integrity. The active vector may be the primary vector (distal RA ring electrode to the pacemaker case) or secondary vector (distal RV ring electrode to the pacemaker case). Since either vector may be used to measure MV, at least one of the implanted leads must have normal bipolar lead impedances. Typically the MV sensor signal is appropriately filtered out by the pacemaker. However, if a high impedance condition is detected within the lead-pacemaker system, the MV sensor signal may be oversensed (Figure 2).

Figure 2. Example of MV signal oversensing

- For pacemaker-dependent patients, turn the MV sensor “OFF”. Note when programmed to passive, the MV sensor signal is enabled and may be oversensed. See Appendix B for details on turning the MV sensor “OFF”.

- For all other patients, evaluate the risks of oversensing the MV sensor signal against the benefits of MV sensor indicated pacing. If the risk outweighs the benefit, turn the MV sensor “OFF” (see Appendix B).

- If transient, abrupt changes or any out-of-range RA/RV pacing impedance measurements are observed, contact Boston Scientific Technical Services to explore all non-invasive programming options prior to surgical intervention. In most cases, management of the system can be done non-invasively through programming changes.

- In accordance with the pacemaker manual, if MV sensor signal artifacts are observed on EGMs and leads are performing appropriately, consider programming the sensor to “OFF” to prevent oversensing.

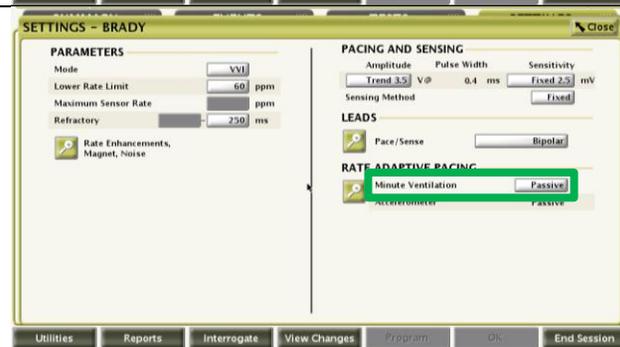
3. On Settings – Brady page, in the Rate Adaptive Pacing section, review the Minute Ventilation programmed value.

If the value is “Passive” or “ON” the MV sensor is enabled.

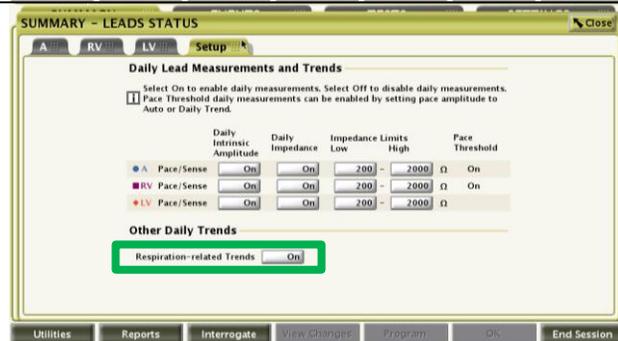
3. On the Summary – Leads Status page, in the Other Daily Trends section, review the Respiration-related Trends value.

If the value is “ON” the MV sensor is enabled.
